Localization of wood floor structure by infrared thermography

C. Cochior Plescanu, M. Klein, C. Ibarra-Castanedo, A. Bendada, X. Maldague
Electrical and Computer Engineering Department, Université Laval
Québec (Québec), Canada, G1V0A6

One of our industrial partners, Assek Technologie, is interested in developing a technique that would improve the drying process of wood floor in basements after flooding. In order to optimize the procedure, the floor structure and the damaged (wet) area extent must first be determined with minimum intrusion (minimum or no dismantling). The present study presents the use of infrared thermography to reveal the structure of (flooded) wood floors. The procedure involves opening holes in the floor. Injecting some hot air through those holes reveals the framing structure even if the floor is covered by vinyl or ceramic tiles. This study indicates that thermal imaging can also be used as a tool to validate the decontamination process after drying. Thermal images were obtained on small-scale models and in a demonstration room.

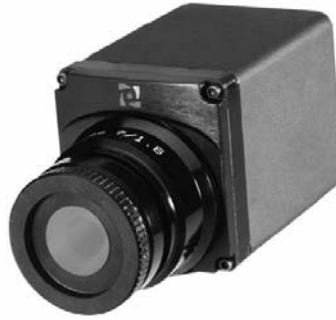
Fig.2. Micron A10 IR Camera.

the concrete floor, the wood floor (Fig.1) and ambient air reaches a heat equilibrium point that is modified by the sudden added moisture due to the flooding. Infrared thermography enables to detect the abnormal temperature equilibrium resulting from flooding and thus the given extent of the wet damaged area thanks to the temperature difference between dry and wet area. In this study, infrared images were taken with a Micro A10 infrared camera sensitive in the 8-12 μm band. It should be noted that images taken by this camera are not temperature calibrated, they only show the temperature gradients (Fig.2).

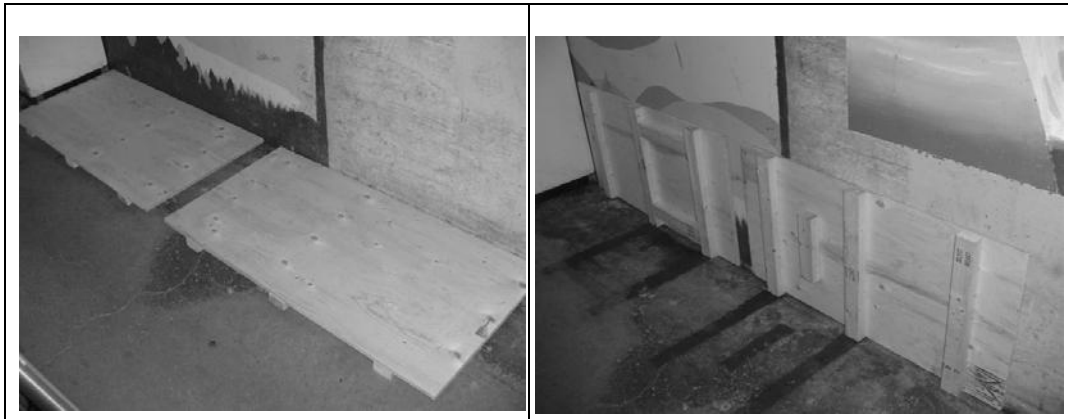
Several small-scale floor models were built. In Fig.3, two models measuring 2ft x 4ft with a 16-inch gap between joists are shown.

Fig.3. Models 2 (right) and 3 (left).

Before the infrared images were taken, the models stayed in water for a period of 8 hours. Only the joists came in contact with water and only one half of each model was kept wet. Ambient temperature in the chamber was approximately 24°C and floor temperature was 19°C. Moisture content measurements were taken with a conventional wood moisture meter. An absolute temperature was recorded using a Mikron MI – N14+ pyrometer.

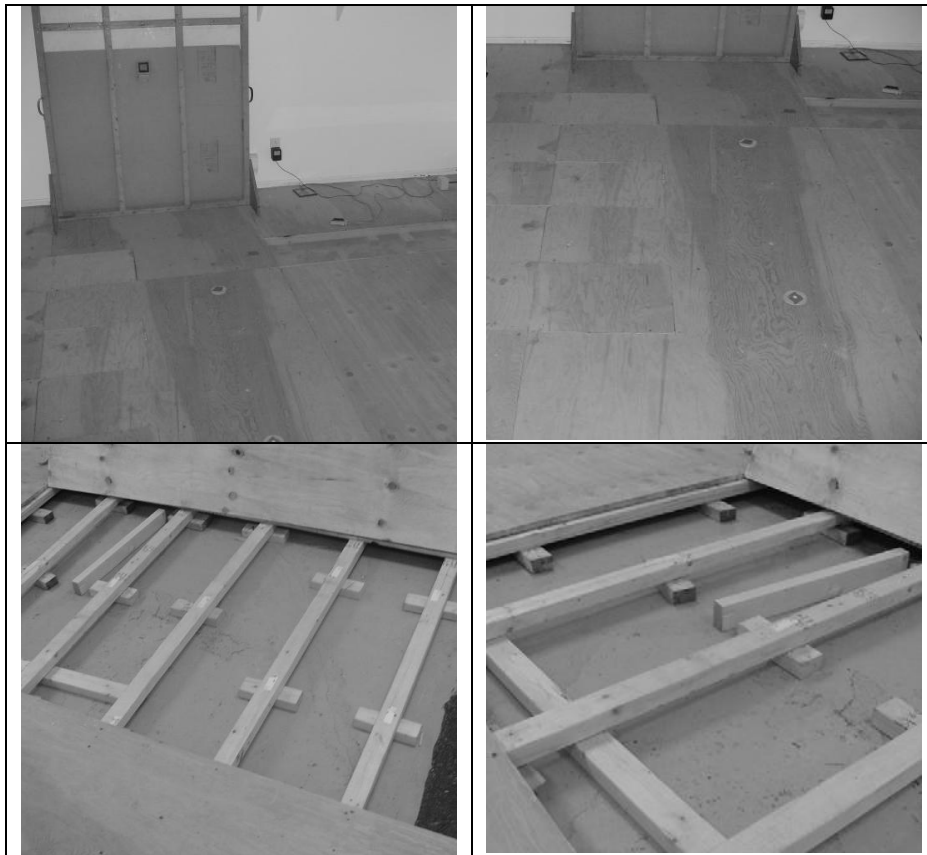
The wood floor framing structure is shown in Fig.9. As shown, the wood floor joists do not rest directly on the concrete floor (there is a 2" clearance over the concrete surface as indicated on the picture).

Fig.9. Test chamber

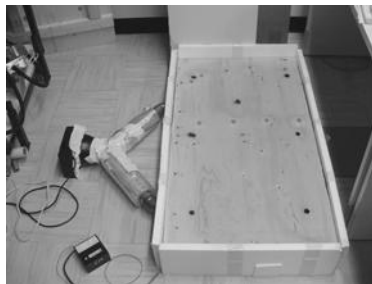
For a better simulation of a basement floor, models 2 and 3 were encased in a Styrofoam box so that they no longer had direct contact with the chamber floor. Hot air produced by an air dryer at about 35 °C was injected in the box with a fan (Fig.14), wet joist moisture content was approximately 14%.

Fig.14. Model 2, insulated in the box

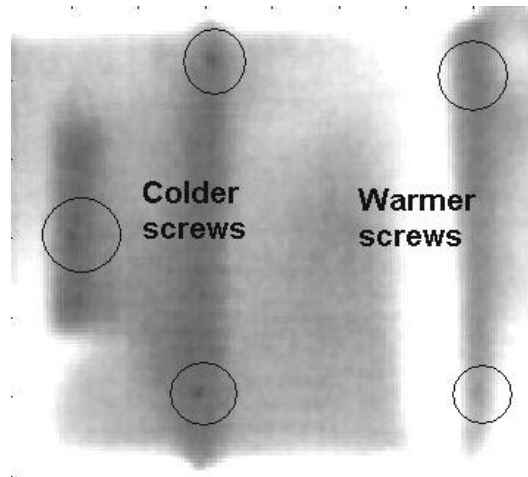
At first, it is impossible to differentiate wet joists from the dry ones. However, when Fig.15 is studied closely, it is possible to notice « black dots » that are in fact the screws holding the joists in place: the screws that fasten the wet joists stay cold longer. Fig.16 shows the same model heated for 15 minutes and left to cool down for 15 minutes: it is now easier to differentiate the colder screws from the warmer ones.

Fig.16. Difference between colder and warmer screws on model 2, after the model was heated.
